TECHNICAL REPORT

NATICK/TR-80/034

COMBAT VEHICLE CREWMAN'S HELMET SURVEY

UNITED STATES ARMY
NATICK RESEARCH and DEVELOPMENT LABORATORIES
NATICK, MASSACHUSETTS 01760

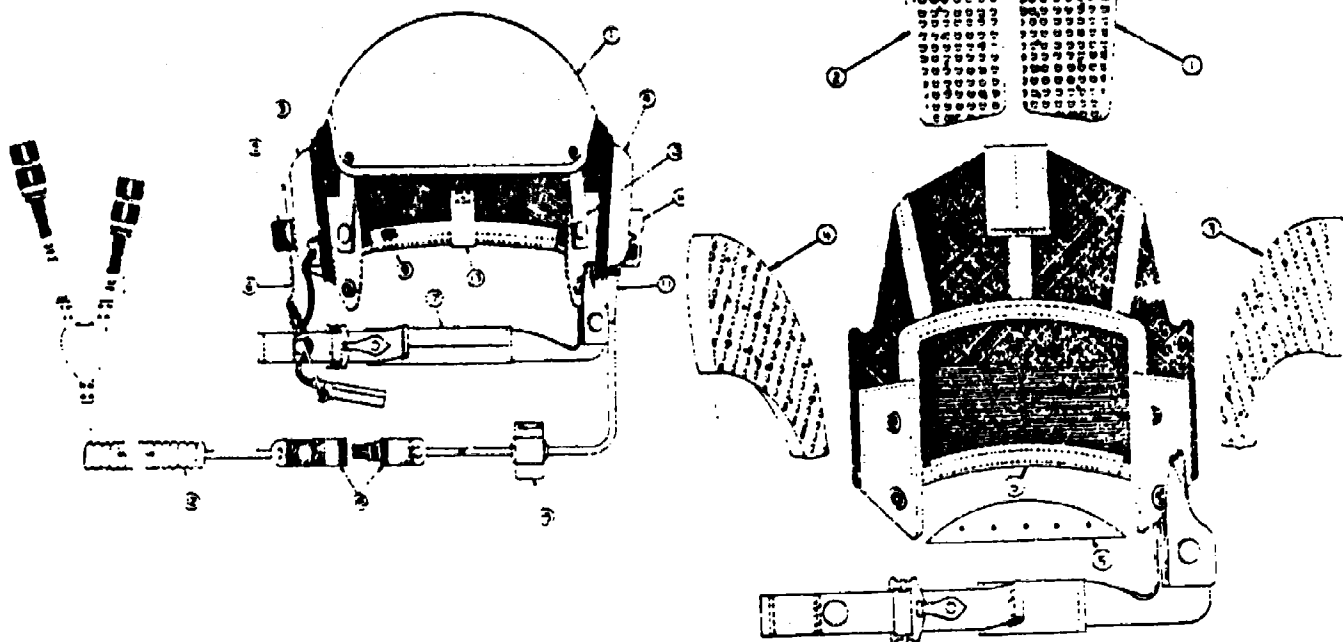
FIGURE 2

COMPONENT PARTS

INNER HELMET

MK-1697/G ELECTRONICS

With the assistance of HQ Training and Doctrine Command (TRADOC), Armor Center, Department of Army, Marine Corps, National Guard Bureau, HQ Forces Command (FORSCOM), HQ US Army Troop Support & Aviation Readiness Command (TSARCOM), and US Army Materiel Systems Analysis Activity (AMSAA), the survey was initiated 3 Jul 79. It was addressed to the armor community in general and to the two data collection agencies, HQ TSARCOM and USAMSAA for review of data related to various problems identified with the T-56 (Figure 1) and DH-132 (Figure 2) Helmets.
